Manhole Inspection Summary

Manhole # S33UU1002MH

Location Address: **5000 SPRINGLAKE WAY**

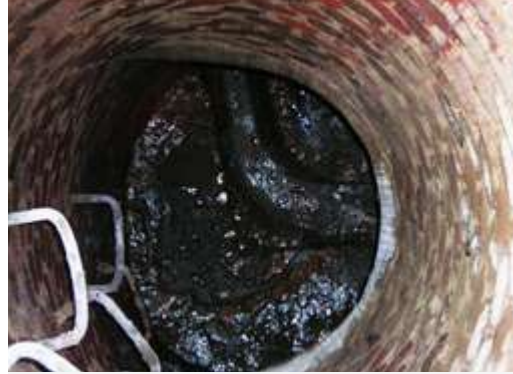
Top View

Steps Count: **7** Missing: **0** ☒ **Corroded**

Surcharge ☒ **Evidence Of Surcharge** Depth: **3** (ft.) ☐ Active Surcharge Present

Corroded steps. Evidence of surcharge - Bench debris.

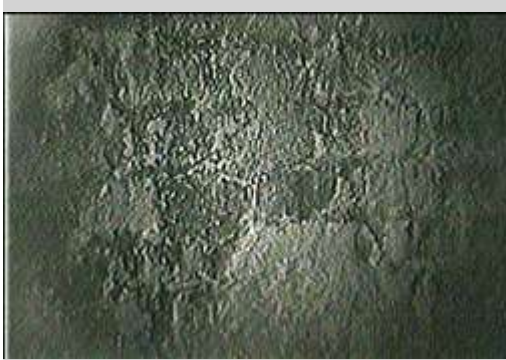
Defect

Infiltration: ☐ None ☐ Joint ☐ Cracks ☒ **Mortar** ☐ Roots ☒ **Wall**

Barrel infiltration.

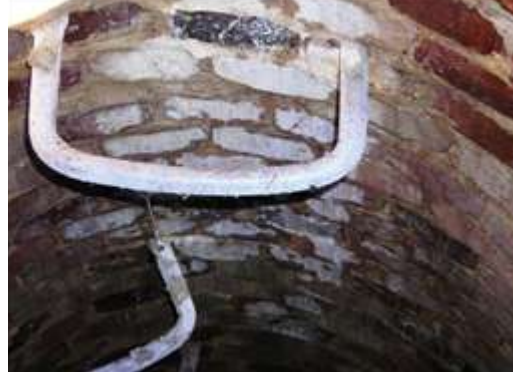
Defect

Infiltration: ☐ None ☒ **Joint** ☐ Cracks ☐ Mortar ☐ Roots ☐ Wall

Infiltration: ☐ None ☐ Joint ☐ Cracks ☒ **Mortar** ☐ Roots ☒ **Wall**

Adjustment and Corbel infiltration.

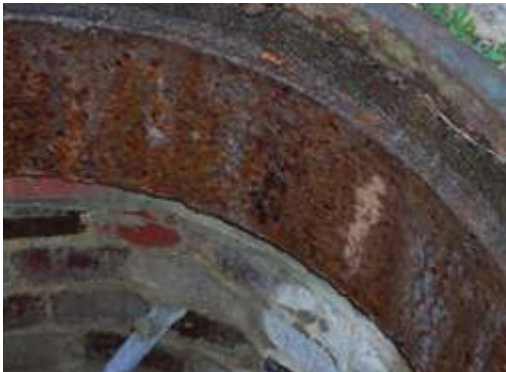
Defect

Condition: ☐ Sound ☐ Cracked ☒ **Leaks**

Frame leaks. Adjustment infiltration.

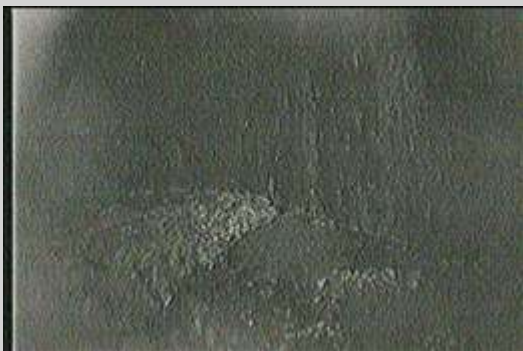
8 in. Circular Gravity Sewer Pipe In @ 3 O'Clock

Comes out of the wall.
